# Manhole Inspection Summary

Manhole # S21SS1013MH

**Location** Address: **HAMILL RD**

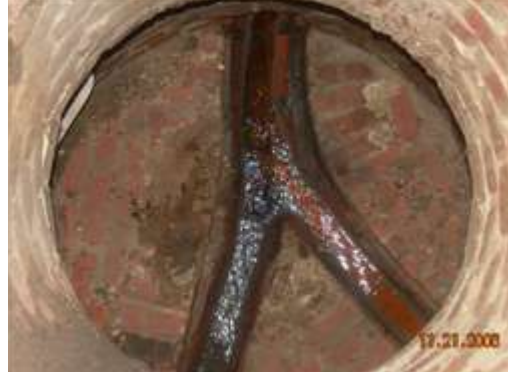
Top View

Bench debris.

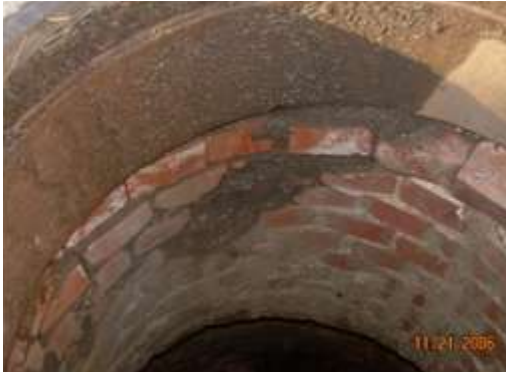
Defect

☒ **Leaks**

Condition: ☐ Sound ☐ Cracked ☐ Root Intrusion ☒ **Loose Brick** ☒ **Deteriorated**

Infiltration: ☐ None ☒ **Joint** ☐ Cracks ☒ **Mortar** ☐ Roots ☐ Wall

Infiltration: ☐ None ☐ Joint ☐ Cracks ☒ **Mortar** ☐ Roots ☒ **Wall**

Frame leaks. Frame offset. Adjustment deterioration, loose brick, and infiltration. Corbel infiltration.

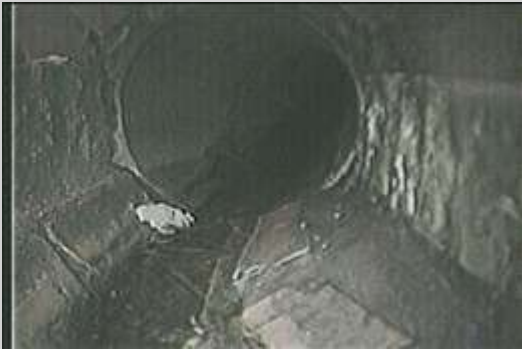
### 10 in. Circular Gravity Sewer Pipe Out @ 12 O'Clock

Infiltration: **Evidence** Pipe Seal Cond: **Unknown**

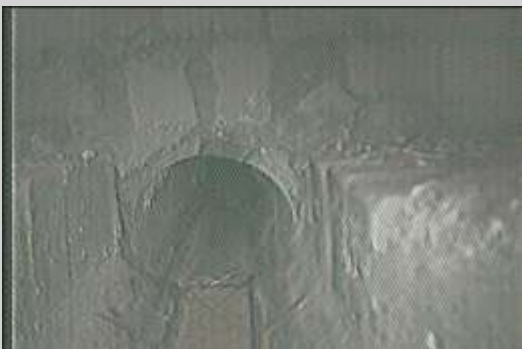
### 6 in. Circular Gravity Sewer Pipe In @ 5 O'Clock

Infiltration: **Evidence** Pipe Seal Cond: **Unknown**

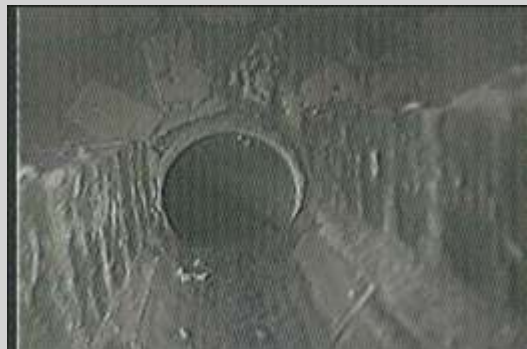
6 in. Circular Gravity Sewer

Infiltration: **Evidence**

Pipe Seal Cond: **Cracked**
